Monitoring Data Record

Project Title: U-3110A (Cook Road Connector) COE Action ID: 199700602

Stream Name: Michael's Branch DWQ Number: 021105

Date Construction Completed: December 2003 Monitoring Quarter: ( 6 ) of 8

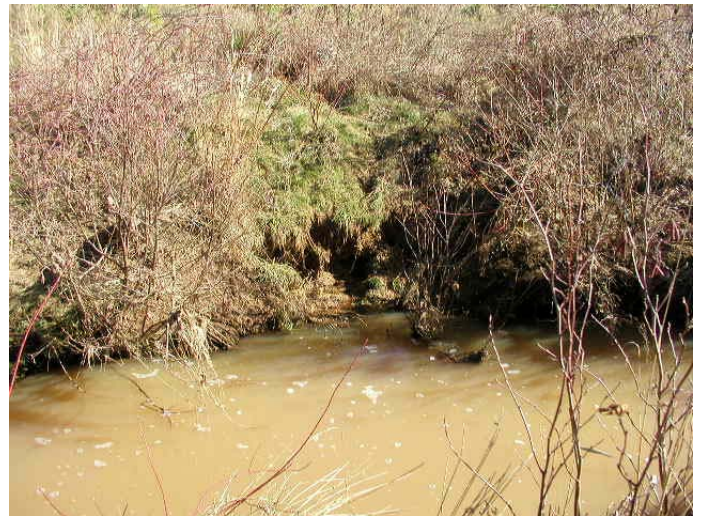
This is the 6<sup>th</sup> quarterly monitoring visit for the Michael's Branch Mitigation Site. The onsite stream relocation has experienced a recent bankfull event. This is the third bankfull event documented since monitoring started in September 2005. The streambanks, which are highly vegetated, have fared well through these bankfull events. This recent bankfull event has caused some minor bank erosion in one of the pools where a coir fiber log was staked into place during construction. The coir fiber log has become displaced which in effect has caused some minor bank erosion (photo shown below). NCDOT will continue to monitor this area to see if any remedial action is needed.

1/10/07	Sta.12+90	Station Number	Station Number	Station Number	Station Number
Structure Type	Pool (Coir Fiber Log)				
Is water piping through or around structure?					
Head cut or down cut present?					
Bank or scour erosion present?	Minor Bank Erosion				
Other problems noted?

Bank erosion at pool
